TOWN OF NORTH ATTLEBOROUGH

TEN MILE RIVER STUDY

Phase I – Preliminary Investigation and Report

BETA Group, Inc.
Engineers • Planners • Landscape Architects
Lincoln, RI - Norwood, MA - Hartford, CT

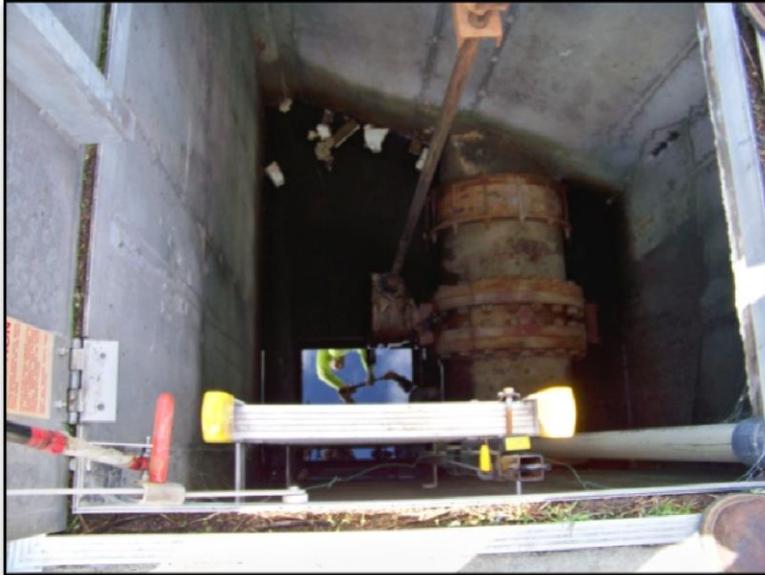
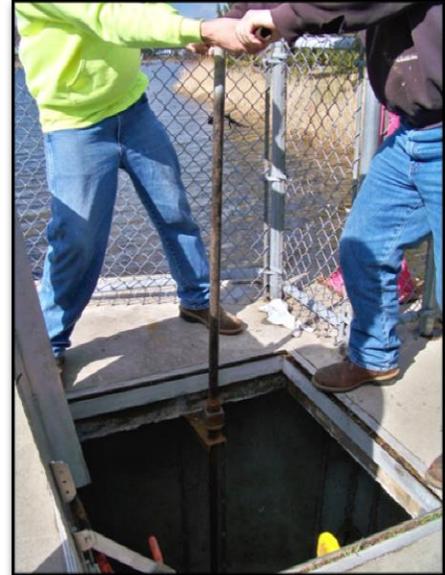
FIGURES 4-1 and 4-2: Closing Butterfly Valve at Whiting Pond Dam (April 1, 2013)

The Whiting Pond dam is controlled by a 16-inch butterfly valve that was installed in the late 1990's inside a vault, as shown in **Figure 4-1**. Currently there is difficulty maneuvering the valve due to alternating wet and dry conditions leading to corrosion. The valve has recently been greased. BETA recommends a new safety hatch and lock to allow for easier and safer access to the gate valve.

In order to open or close the butterfly valve approximately 50 turns are required for each direction. This procedure currently requires two persons due to the difficulty of rotating the valve, as shown in **Figure 4-2**.

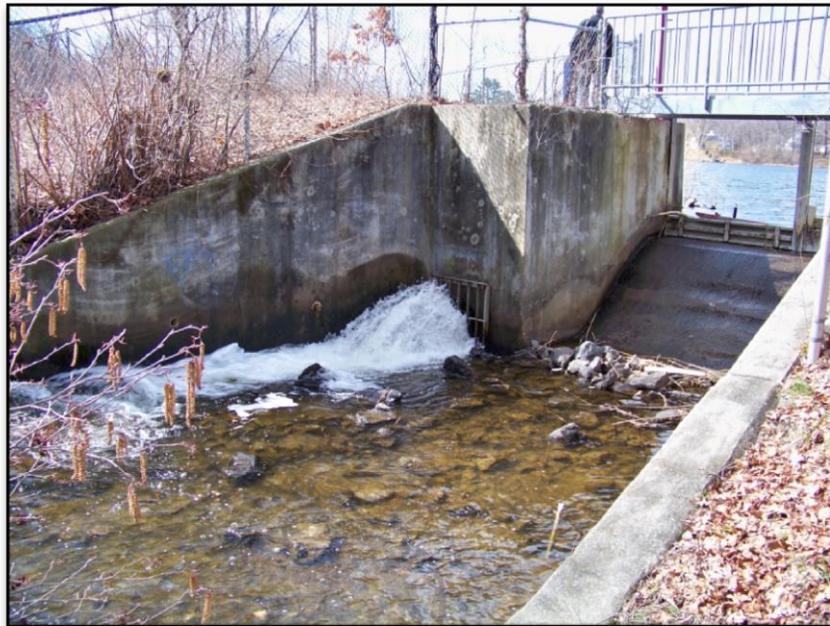
FIGURE 4-3: Whiting Pond Dam before Closing (April 1, 2013)

The valve is closed April 1st every year to increase the water level in Whiting Pond to allow for recreational activities. The valve is opened November 1st every year to allow for snow melt capacity. The dam is under jurisdiction of the conservation commission due to the invasive Japanese knotweed growing next to the dam. Prior to a large rain event after April 1st, the valve is opened approximately 10-12 turns, to create capacity in Whiting Pond. **Figures 4-3 and 4-4** are of Whiting Pond dam before and after closing the valve.

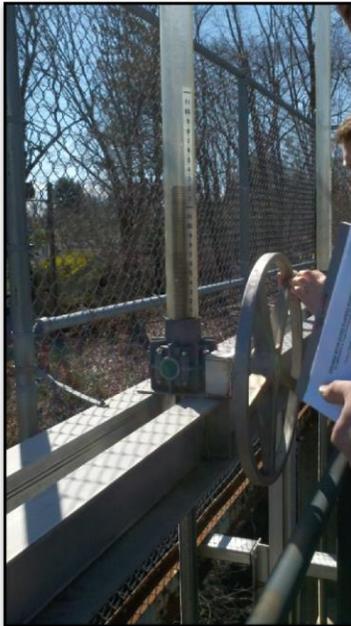
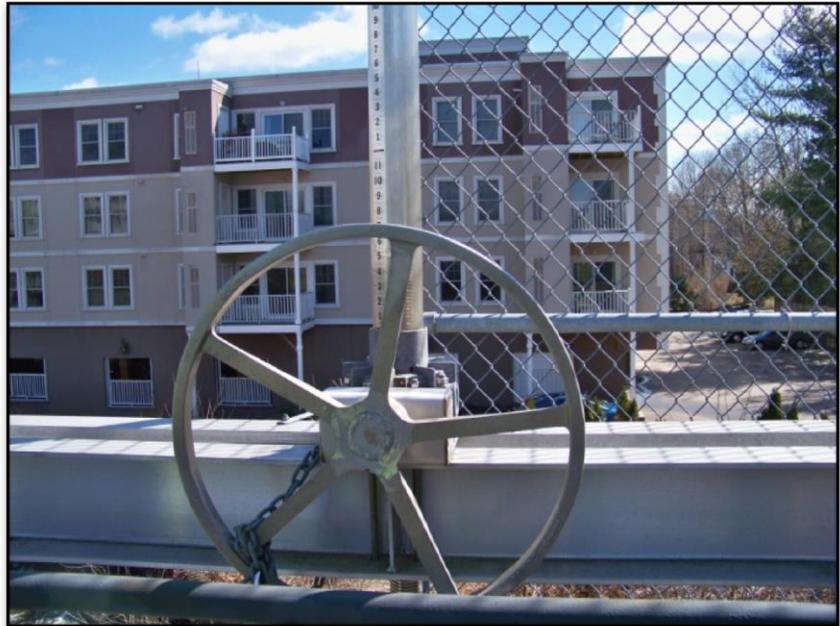
FIGURES 4-5 and 4-6: Falls Pond Dam Gate Opening/Closing Mechanism (April 1, 2013)

Falls Pond dam has four 24-inch sluice gates and two spillways. Under normal operation, flow is controlled by adjusting the sluice gate elevations by manually operating the handwheels for each gate. In unusually high flow conditions, operation is limited to the three sluice gates furthest right facing Falls Pond. Due to the close proximity of the Falls View Condominiums immediately downstream of the dam, caution must be taken to limit the amount of flow passing through the dam due to capacity limits, foundation concerns, and noise.

Similar to Whiting Pond dam, the Falls Pond dam is closed approximately April 1st and opened November 1st every year. During the winter months, either one gate will be left open set to 9 inch height or both gates will be left opened at 5 inch height. Before fully closing the dam for the summer, the gates are opened fully momentarily to allow debris to be removed. The left gate facing Falls Pond is remains only partially open due to the amount of noise and close proximity to neighbors.

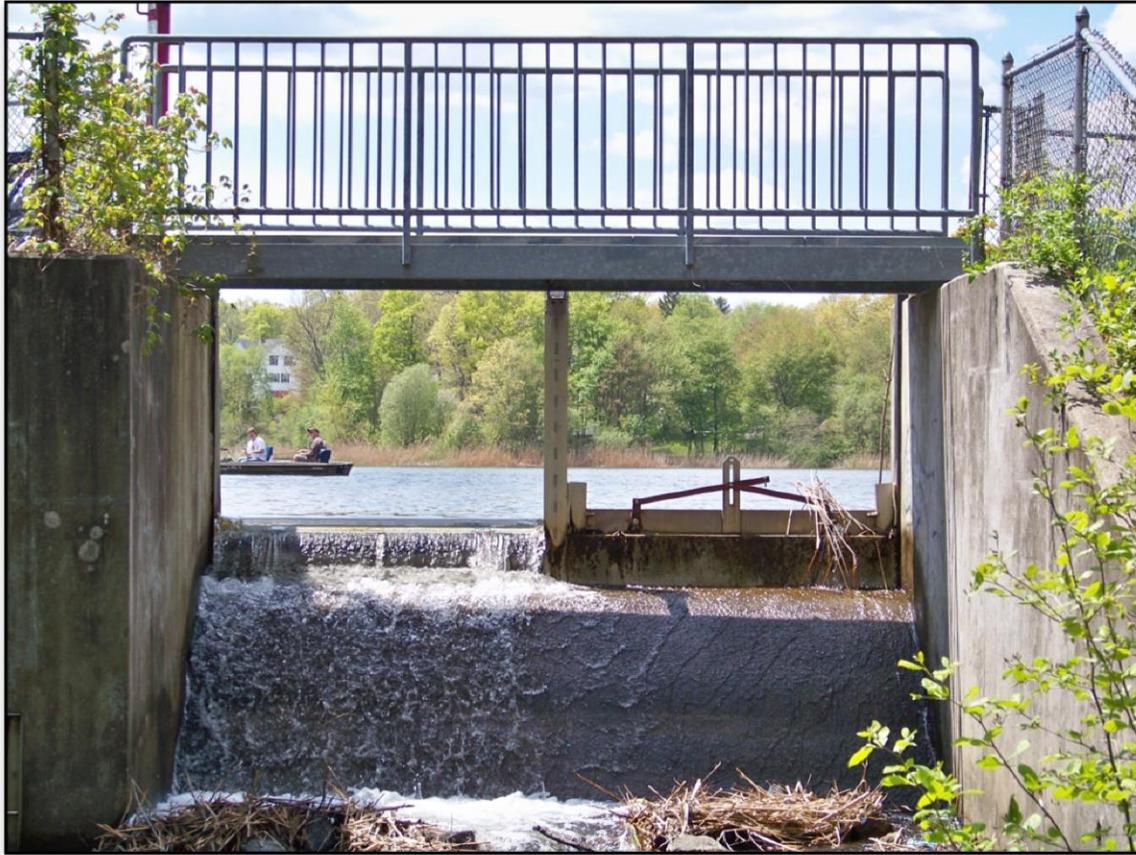
FIGURES 4-9: Whiting Pond Dam Dimensions

Figure 4-9 below illustrates the information gathered during the investigation. Stop logs can be added and removed to regulate flow through the dam.

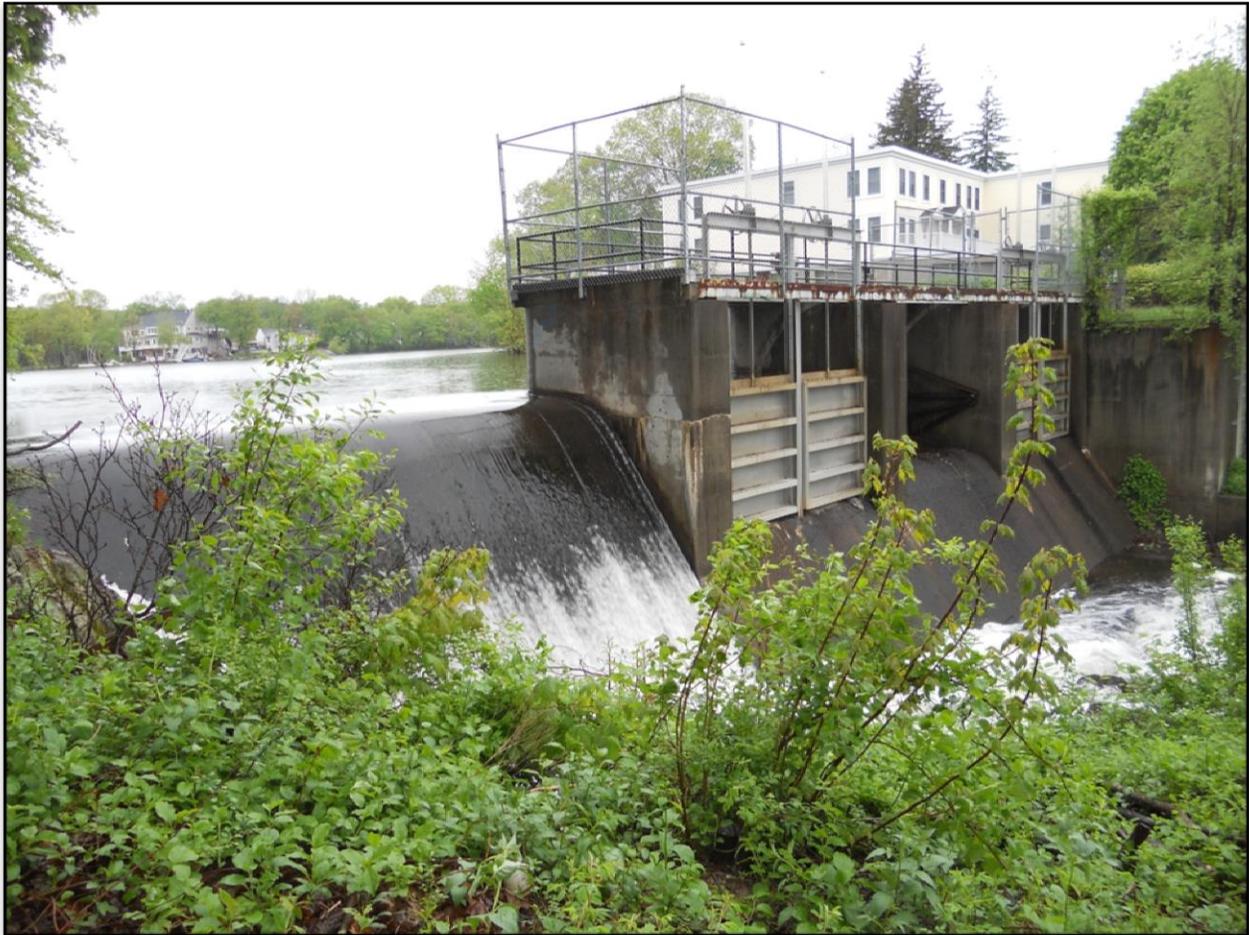
Figure 4-10 below illustrates the information gathered at Falls Pond dam. The four gates can be raised up to 2-feet to regulate flow through the dam. Assumptions are listed in the figure.

1. IT IS ASSUMED ALL GATES ARE IDENTICAL AND AT THE SAME ELEVATION.
2. IT IS ASSUMED THAT THE ELEVATION AT THE BOTTOM OF THE GATES IS 1 FOOT BELOW THE BOTTOM SPILLWAY 2 ELEVATION, BASED ON OBSERVATION.
3. THE ELEVATION AT THE TOP OF THE SPILLWAY 2 IS BETWEEN THE ELEVATION OF SPILLWAY 1 AND THE TOP OF THE GATES.
4. FIELD WORK CONDUCTED JULY 12, 2013.

Based on the dimensions in **Figure 4-10**, equations were established to calculate the discharge rate for each gate and spillway. These equations can be found in **Appendix B**. The amount of discharge through the dam is dependent on the water level of Falls Pond.

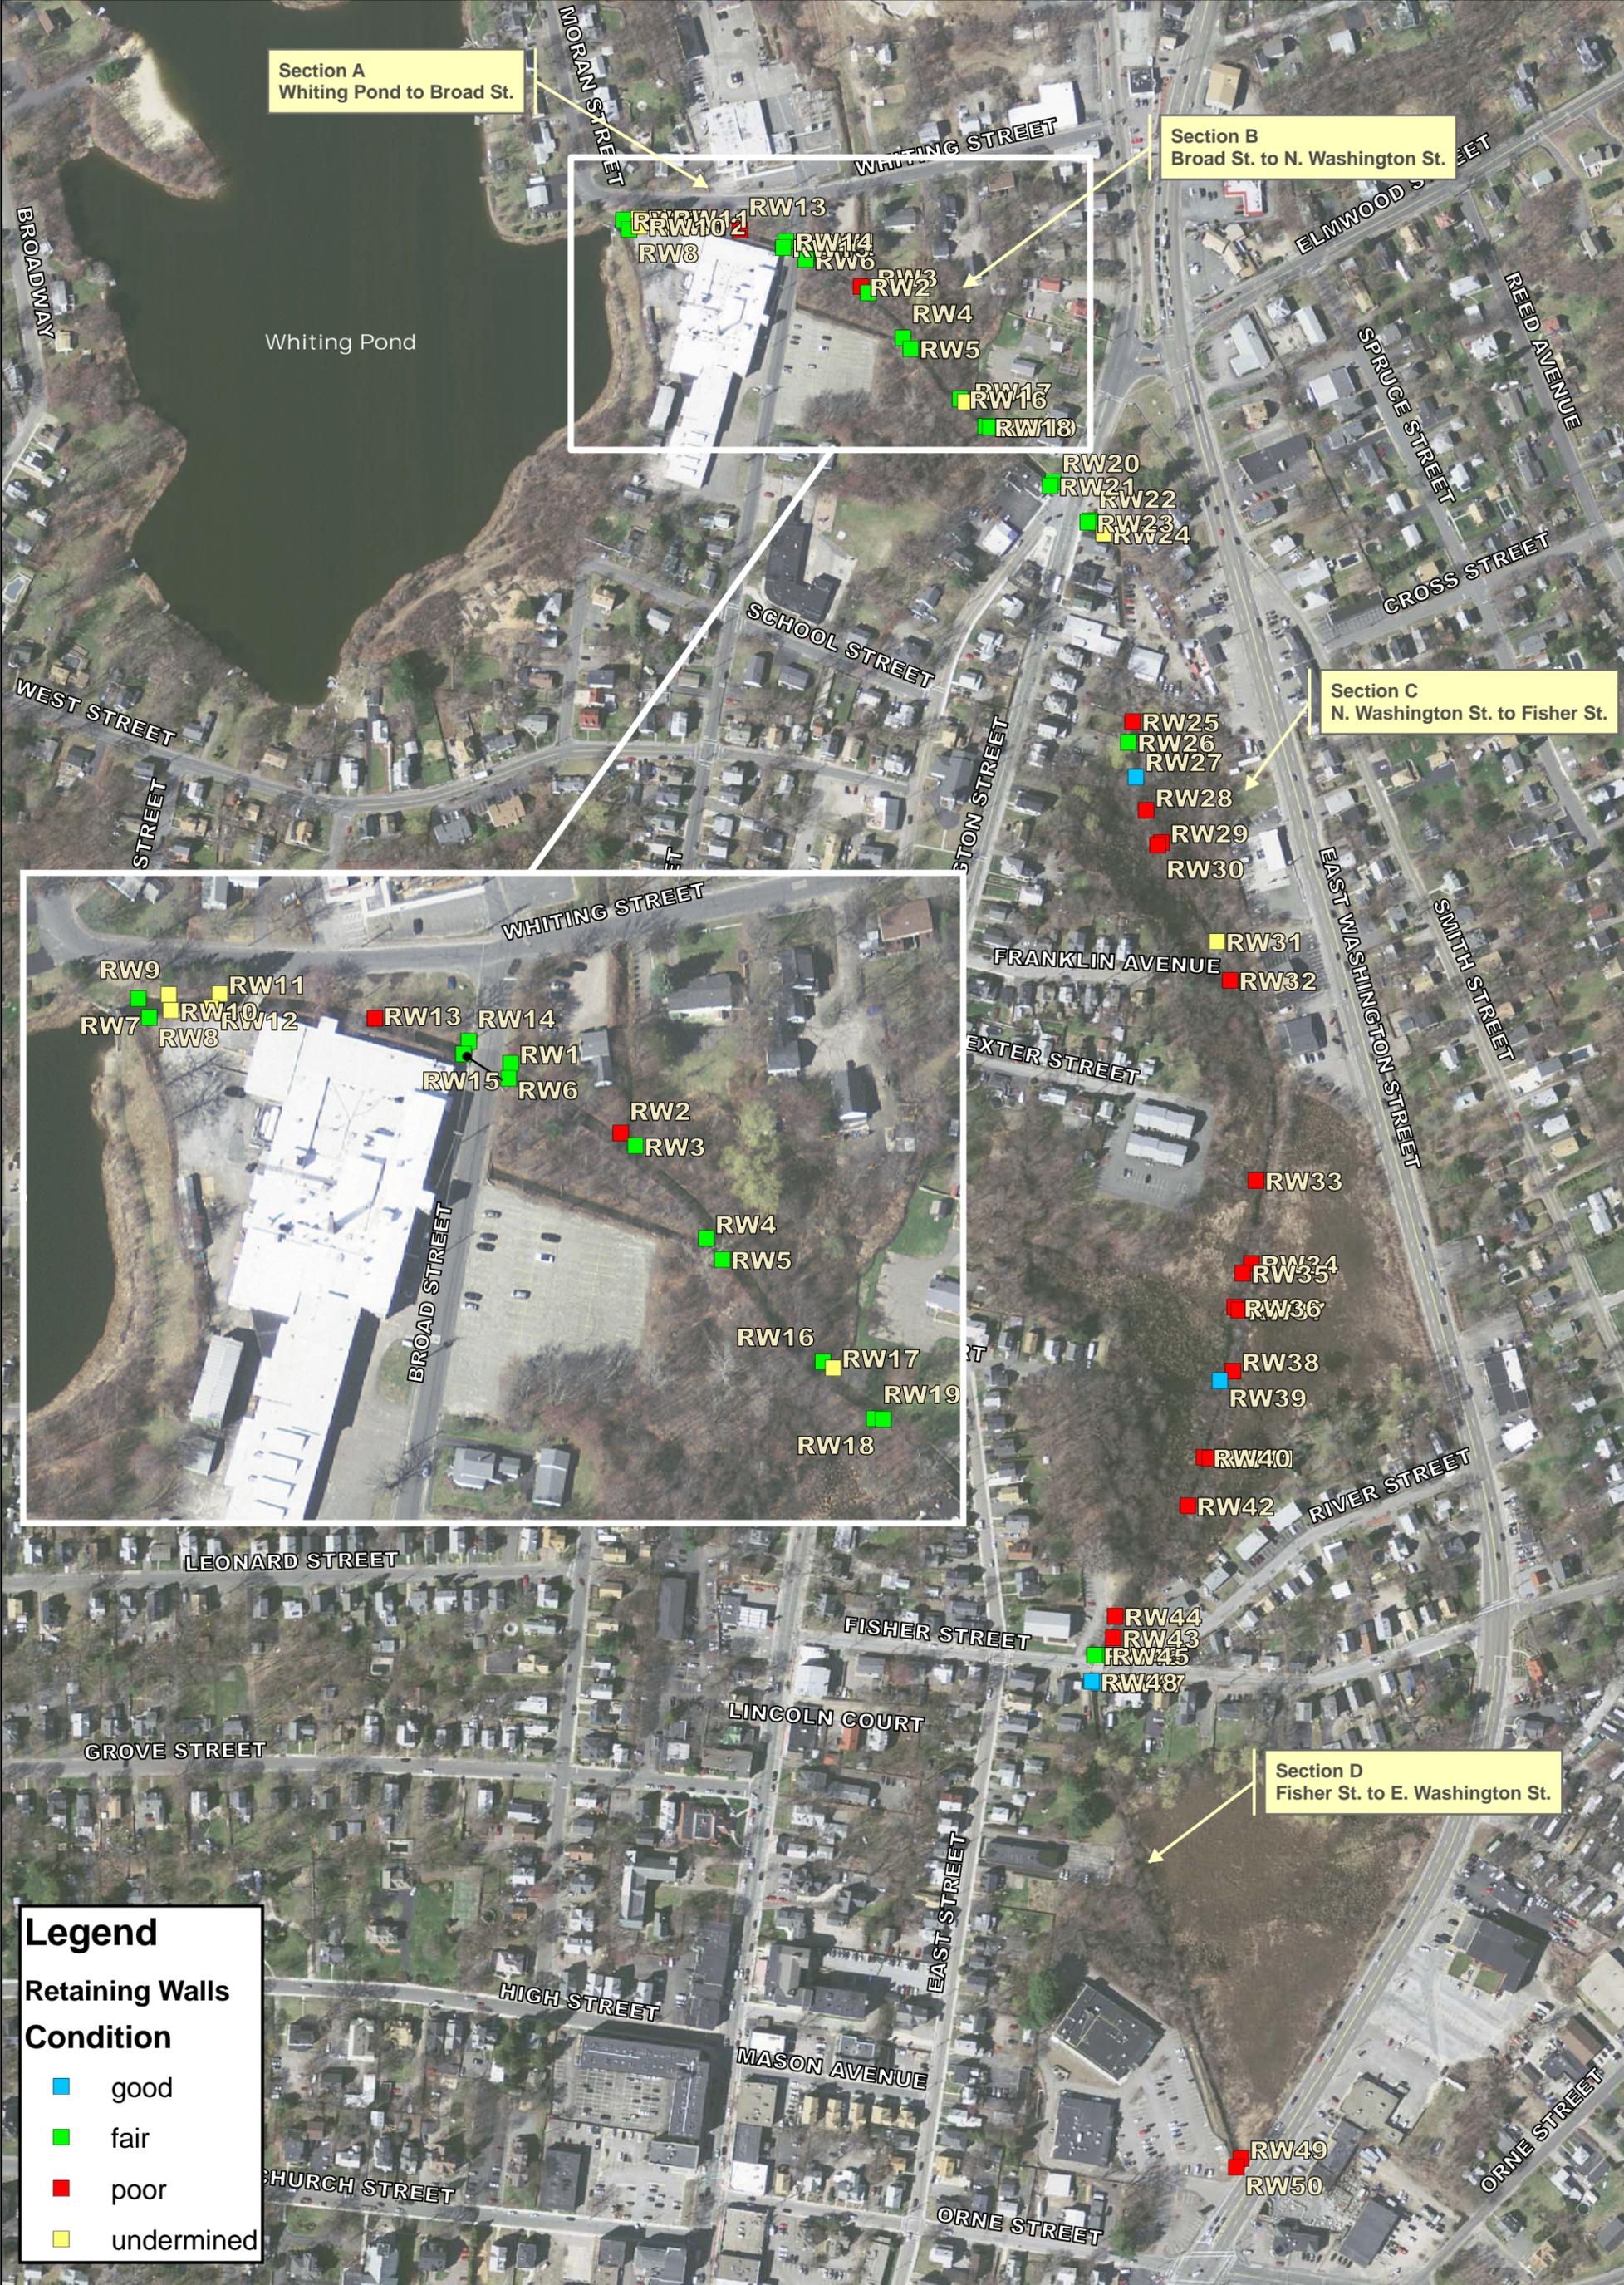
Figure 6-1A: Retaining Walls Conditions

Data points were established at the start and finish of each section for each side of the river. Additional data points were collected for atypical portions of the walls such as gaps in the wall, missing walls, heavy damage, collapses, or undermining. **Figures 6-1A and 6-1B** show the location of each data point collected.

As seen in **Figures 6-1A and 6-1B**, large portions of the retaining walls along the river are in poor condition, sections C, D, F, and G being in the worst condition. Sections A and B, although generally in fair condition, had several undermined areas. Section G was the only area that was in generally good condition.

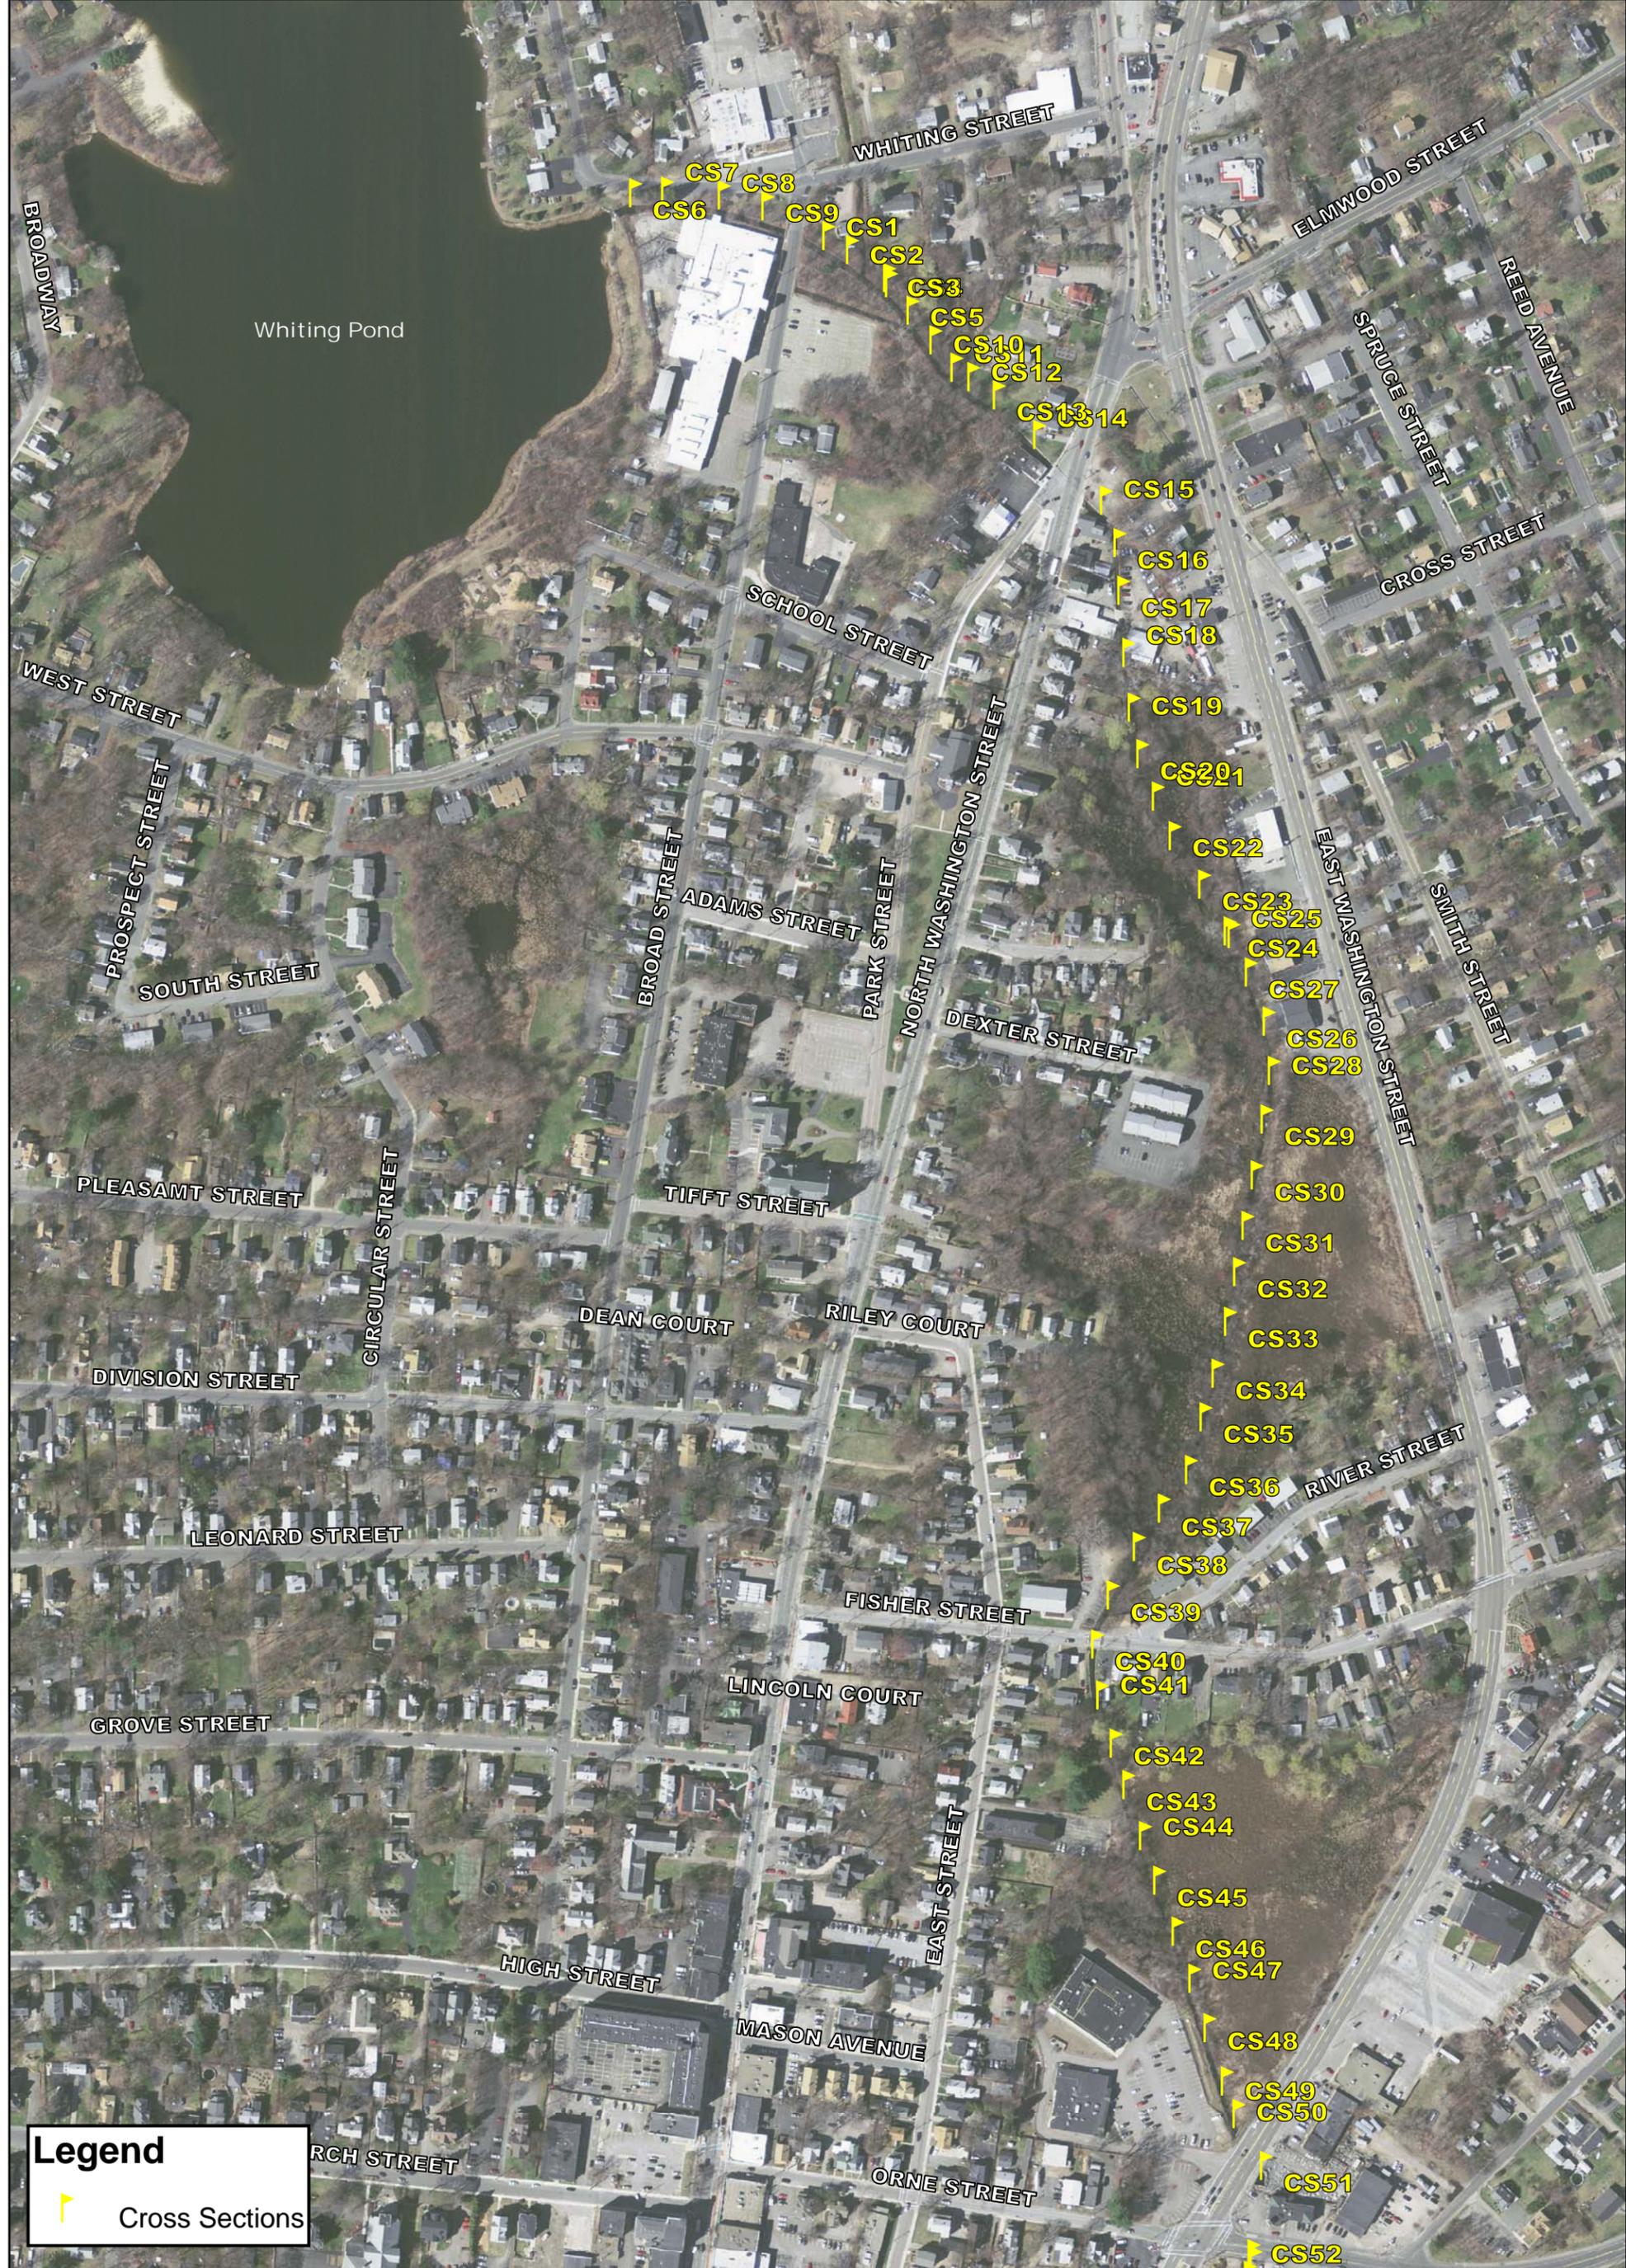
Figure 6-3A: Sediment Cross Section Locations

In order to assess the sediment, the Whiting Pond dam was closed to lower the water level. Two BETA engineers hiked in and along the river, stopping approximately every 100 feet to collect a data point. Cross-sectional data was also collected at places where sediment deposits were uncharacteristic for the section of river. Information was recorded using an iPad and Utility Cloud software. A map of the Cross-Section data collection spots is shown in **Figures 6-3A** and **6-3B**.

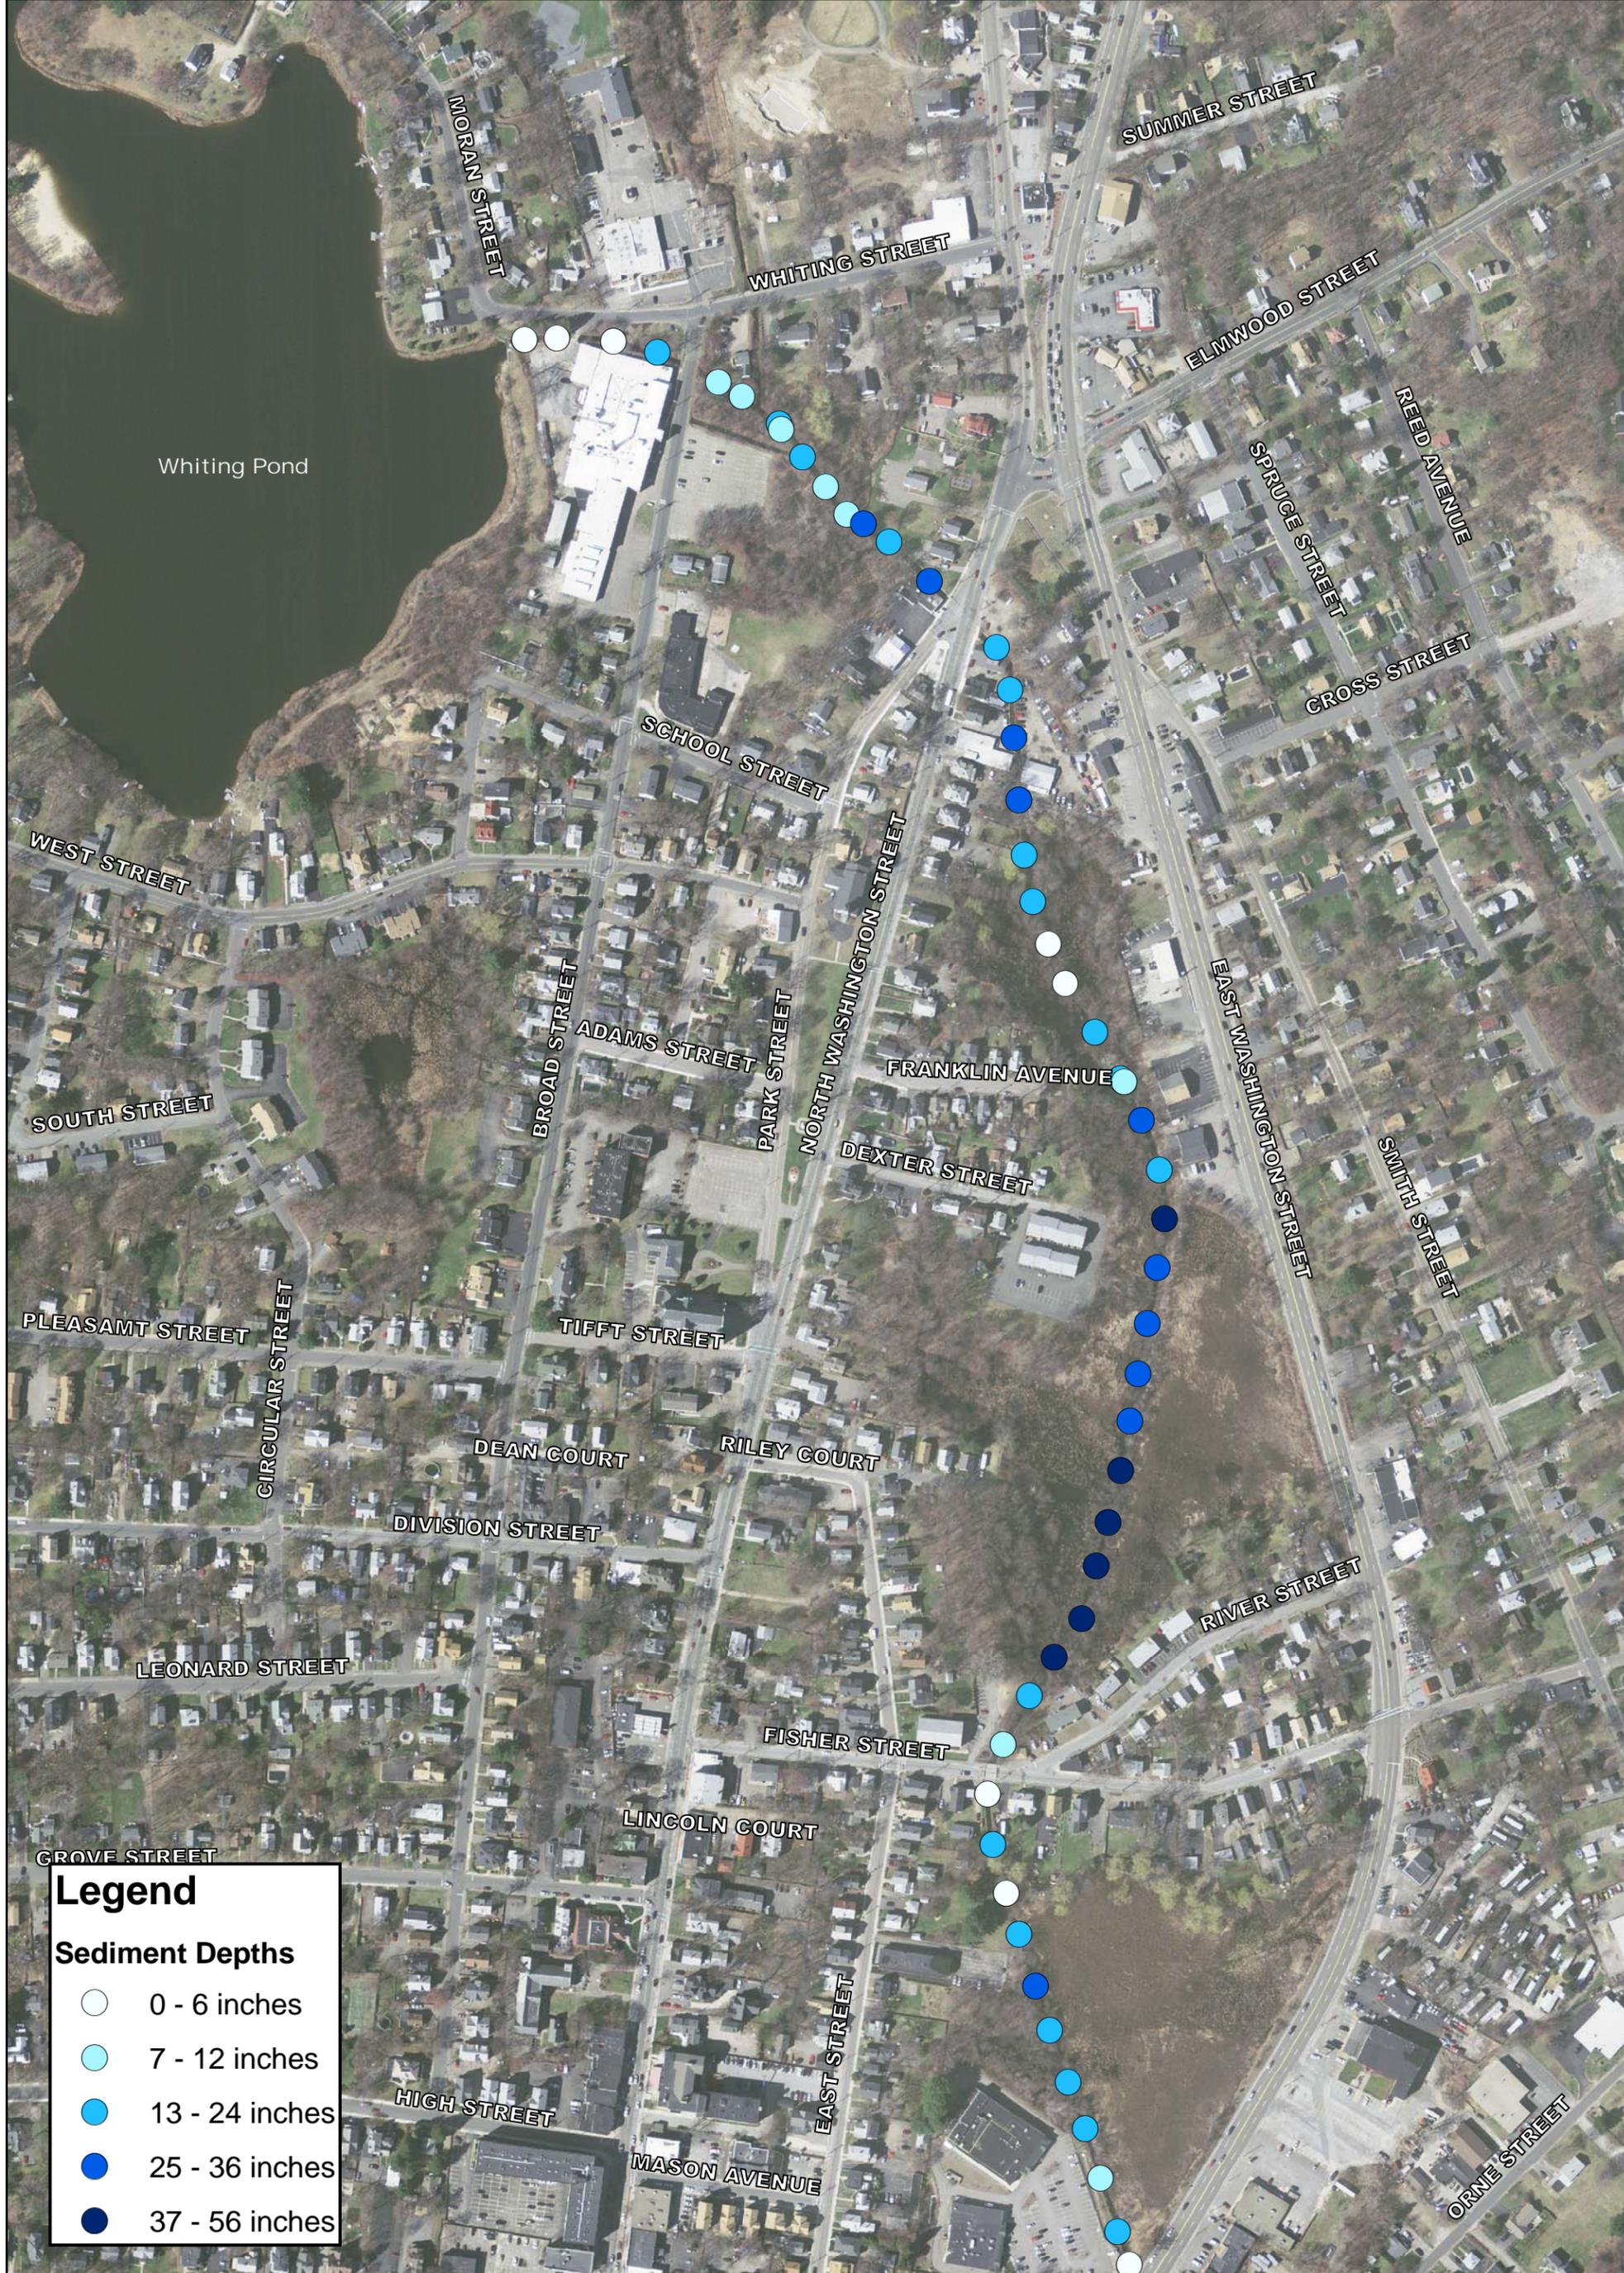
Figures 6-6A and **6-6B** illustrate the varied depth of sediment along the river. The middle sediment depth was used since it best depicts the overall sediment conditions at each section of the river.

The most significant sediment deposits were in the wetlands between North Washington Street and Fisher Street. The sediment in this area had been previously dredged, however, sediment has collected in these areas. Water and sediment depth totals for this area were 2-4 feet deeper than other areas of the river.

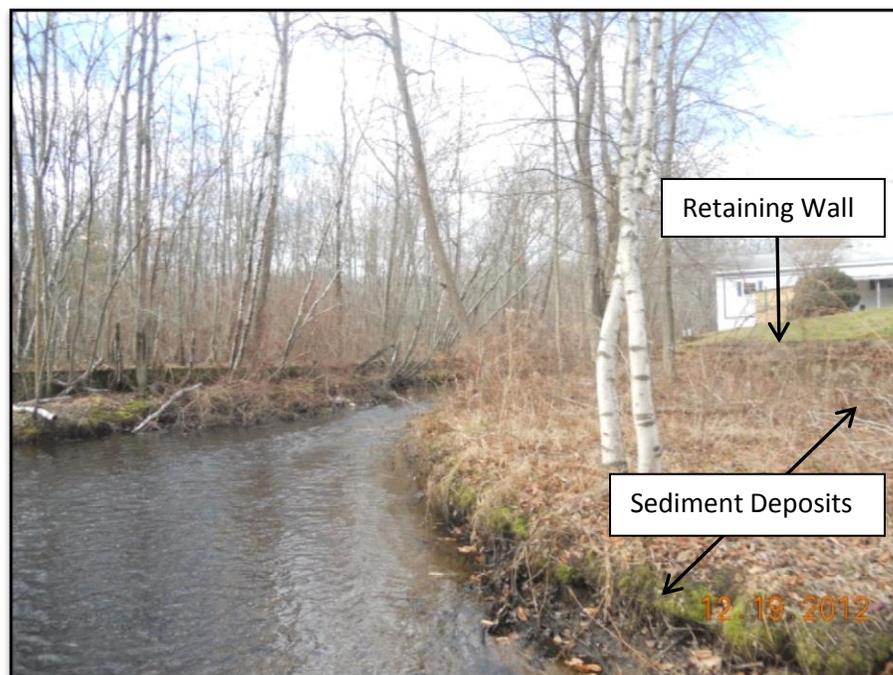
FIGURE 6-7: Ten Mile River Bend before East Washington Street

Another sediment issue was in Sections G and H between Chestnut Street and East Washington Street. Although there was little sediment deposit in the middle of the river, along the retaining walls, especially at the river bend, enough sediment has collected over the years that trees and plants have been able to grow in the sediment banks. **Figure 6-7** is a picture of the sediment deposits at the river's bend before East Washington Street.

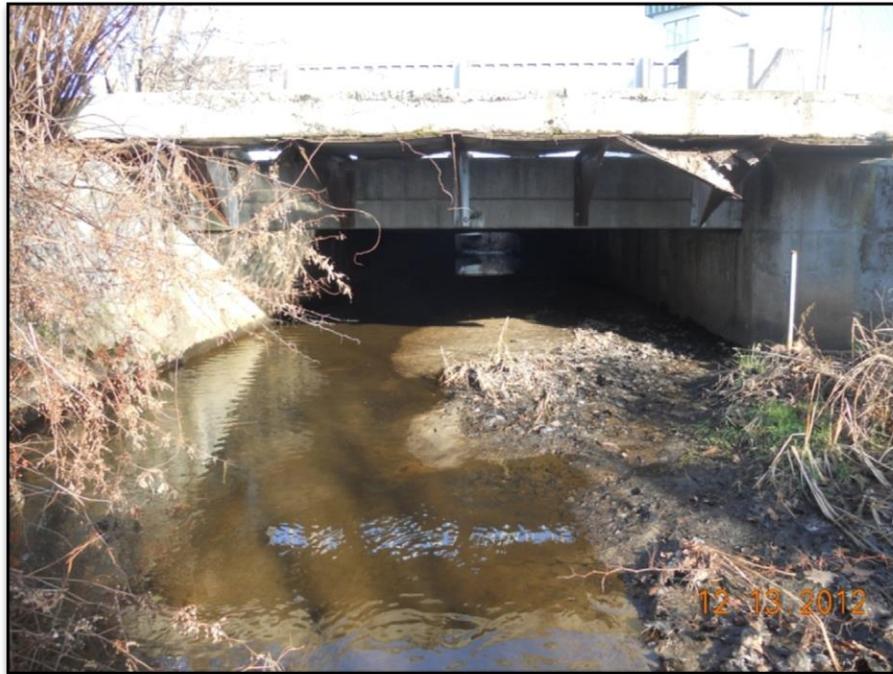
FIGURE 6-8: Sediment Buildup South Side of Orne Street Culvert

Due to the bend in the river near Orne Street and Elm Street, sediment has built up near and inside of the culverts. Low water velocity and culverts has led to large sediment bars and deposits, obstructing the natural flow of the river. **Figures 6-8** through **6-10** are examples encountered during the field investigation. At CS-60 where **Figure 6-10** was taken, the sediment depth was measured to be 56 inches.

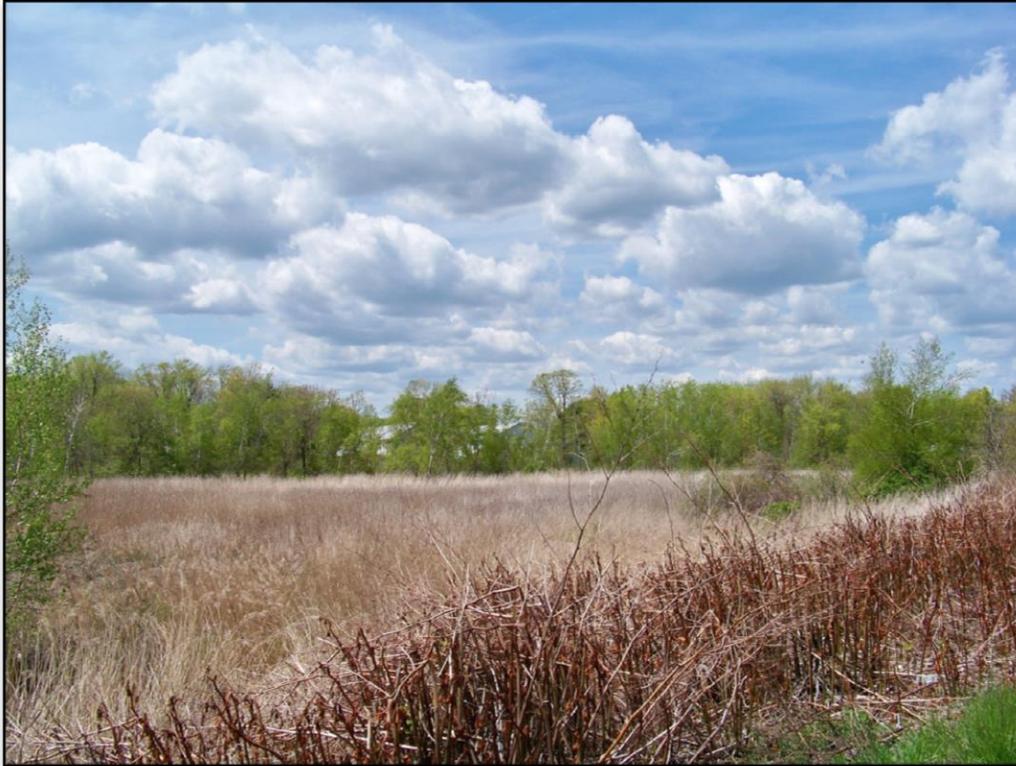
FIGURE 7-2: Looking at Potential Storage Area 1 from Route 1

To use either area as potential stormwater storage, several steps would need to be taken. **Figure 7-2** illustrates the areas are filled in with sediment and invasive phragmites. Due to the area's industrial discharge history, there is a potential for soil contamination, including heavy metals. Soil would need to be tested and if dredged, the materials for disposal would need to be permitted and likely disposed as hazardous, increasing restoration costs. Phragmites would also need to be eradicated. An added benefit to restoring the area is to bring back functioning natural wetlands.
